## Important Recall Notice

With our dedication to safety and quality in mind, Shimano is issuing a voluntary recall of some bonded 11-speed Hollowtech road cranksets produced before July 2019 for a possible bonding separation issue.

### Crank Identification and Inspection Process

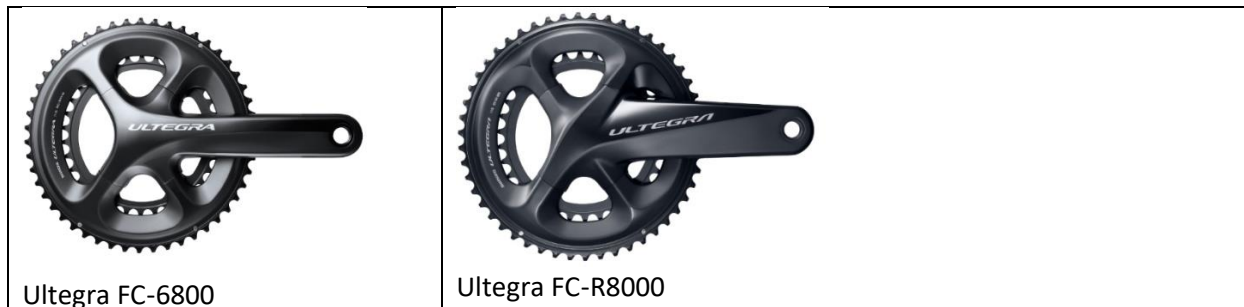
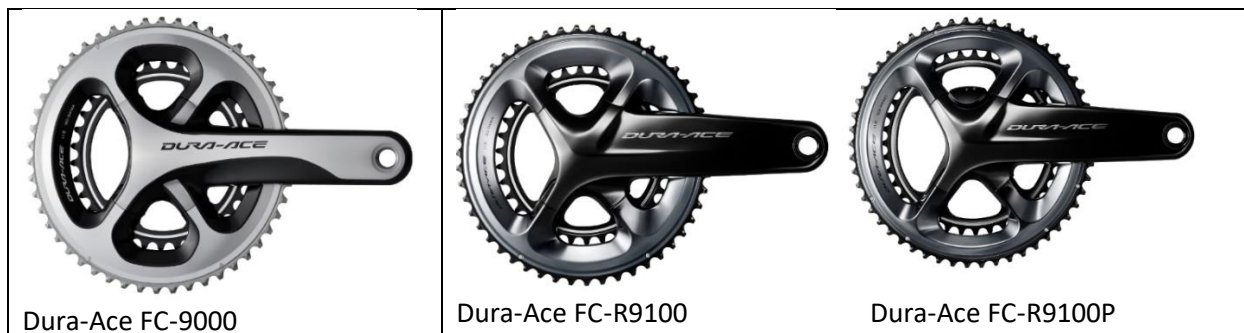
- **Step 1A – Identify the model number of your crankset**
- The affected model numbers are DURA-ACE and ULTEGRA branded cranksets with the following model numbers: **ULTEGRA FC-6800, FC-R8000 and DURA-ACE FC-9000, FC-R9100 and FC-R9100-P**. The model numbers are stamped on the inside of the crank arm near the bottom of the arm (see yellow square in the] image below).
- **Does the model number on your crank arm match the model numbers above?**
- **NO:** The crank is not affected, and no further action is needed.
- **YES:** Proceed to STEP 1B.

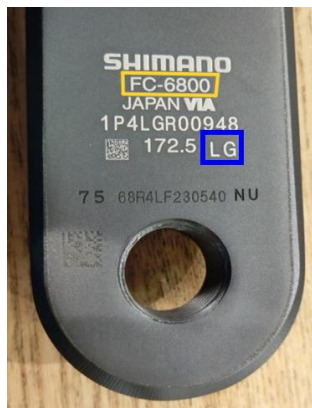
## Step 1B – Identify the production code stamped on your crank arm (blue box on the image below)

- A production code is stamped on the inside of the crank arm near the bottom of the arm. The affected models are pre-July 2019 production and have the following two-letter production code on backside of the crank arm where the pedals are attached: KF, KG, KH, KI, KJ, KK, KL, LA, LB, LC, LD, LE, LF, LG, LH, LI, LJ, LK, LL, MA, MB, MC, MD, ME, MF, MG, MH, MI, MJ, MK, ML, NA, NB, NC, ND, NE, NF, NG, NH, NI, NJ, NK, NL, OA, OB, OC, OD, OE, OF, OG, OH, OI, OJ, OK, OL, PA, PB, PC, PD, PE, PF, PG, PH, PI, PJ, PK, PL, QA, QB, QC, QD, QE, QF, QG, QH, QI, QJ, QK, QL, RA, RB, RC, RD, RE, and RF. Please proceed to Step 2 if your crank has this code. If your crankset does not have one of these codes, please proceed to step 3.
